RECREATIONAL BOAT SAFETY COLLISION RESEARCH-PHASE II  
VOLUME II - COLLISION ACCIDENT INVESTIGATIONS - 1975

Wyle Laboratories  
Huntsville, AL

Jul 76

REPORT NO. CG-D-129-76

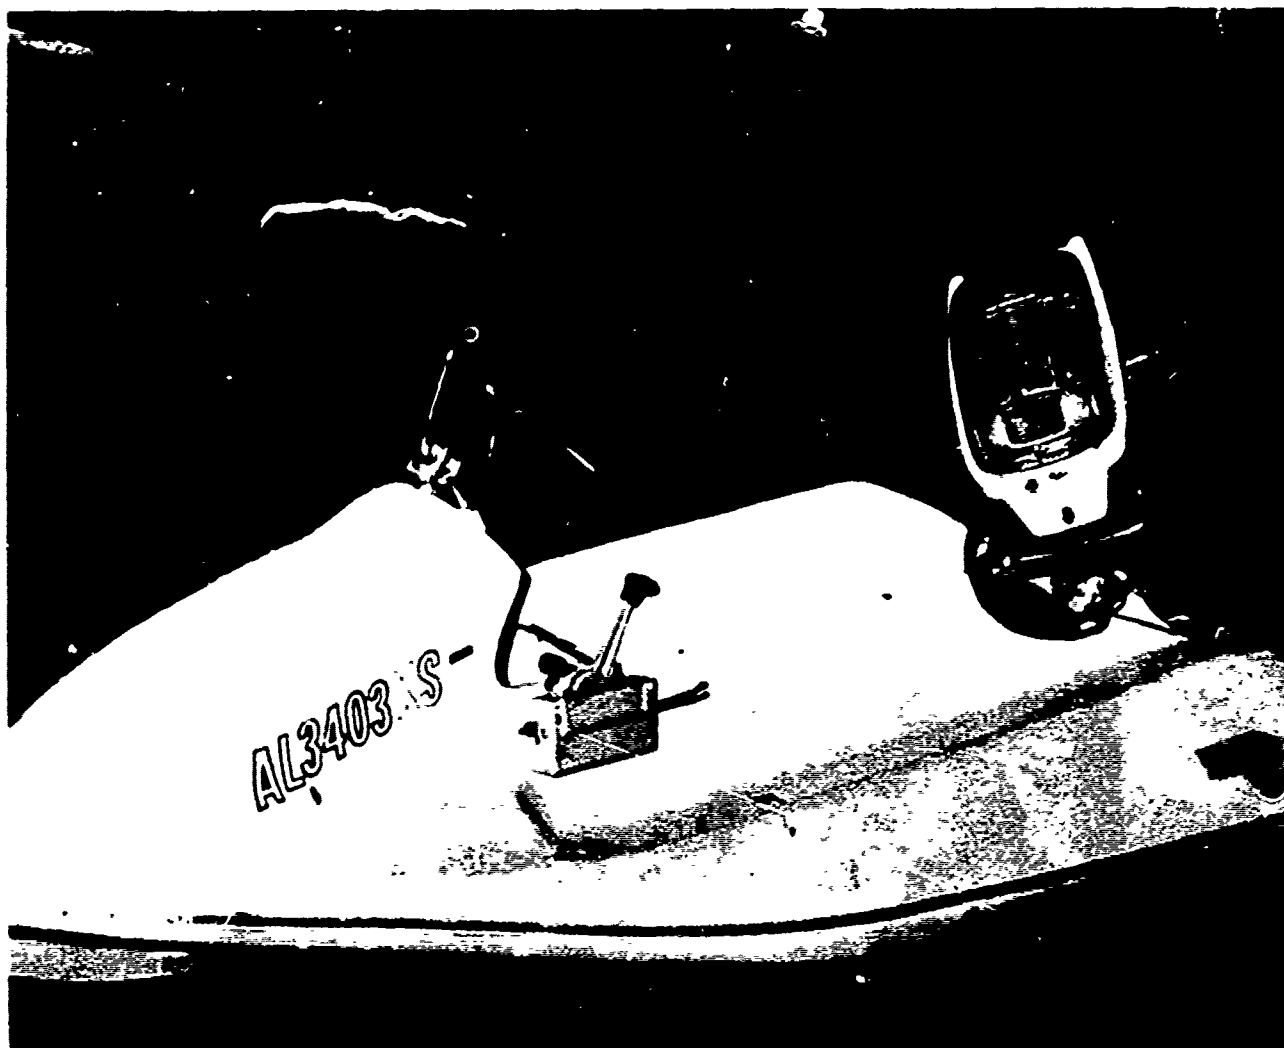
The boat hull photographs, and the testimony of the investigating officer and the bystander all indicate that damage was found on the starboard side of the water scooter as shown in the boat damage sketch (Figure 3).

The impact velocity was probably quite high (20 - 25 mph) as seen from the damage to the water scooter.

Photograph 2. Water Scooter After Accident No. 166; May 27, 1975

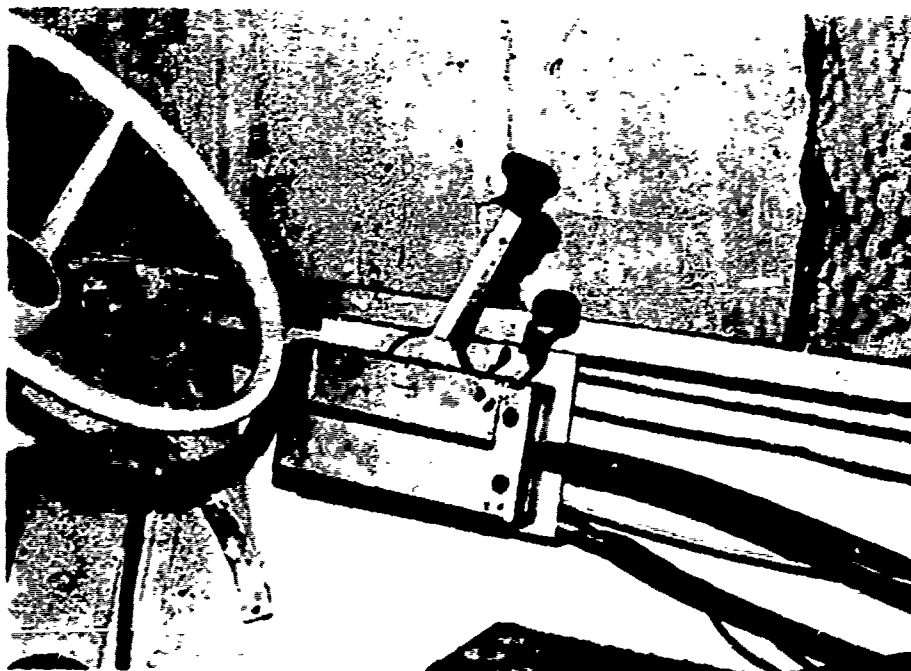
The controls were examined after they had been installed on the neighbors boat (photograph 4) and they apparently operated o.k. Further investigation revealed that the control cables were not used in the new installation, and that the push-pull cable for the throttle was broken about 5 inches up the coux covering. Examination of the motor throttle arrangement showed a "push-to-open-throttle" arrangement. This means that (with a broken cable) the throttle could be advanced, but would probably not retard.

Photograph 4. Water Scooter Shift and Throttle Controls

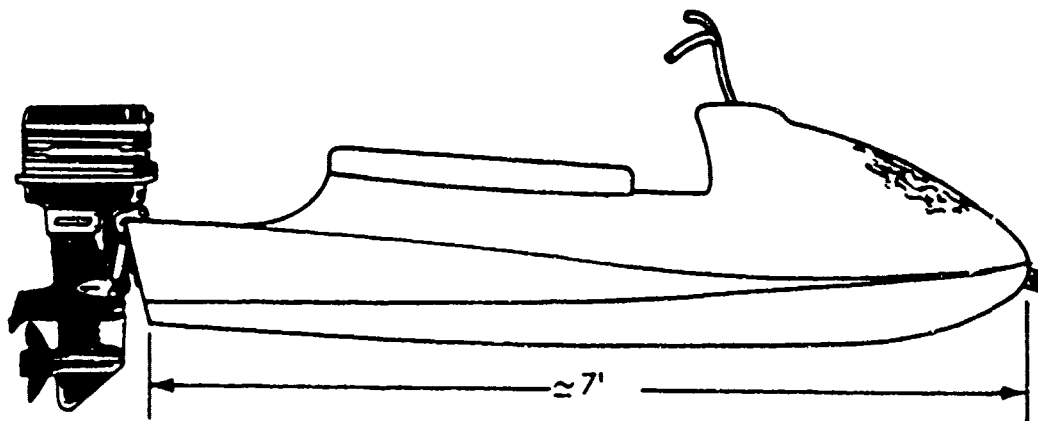
Figure 3. Damage to Boats: Several Nick Marks Less Than 1" Long In Gelcoat At Location Shown on the Water Scooter

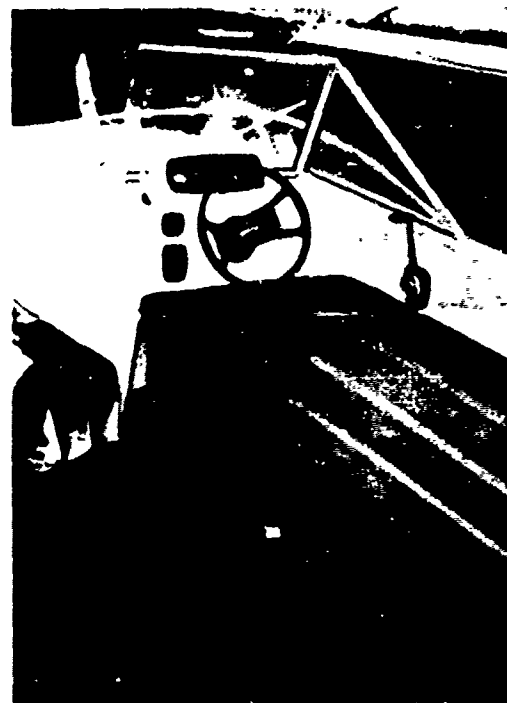
Figure 2. Damage to Boat

Bow Damage

Secondary Damage

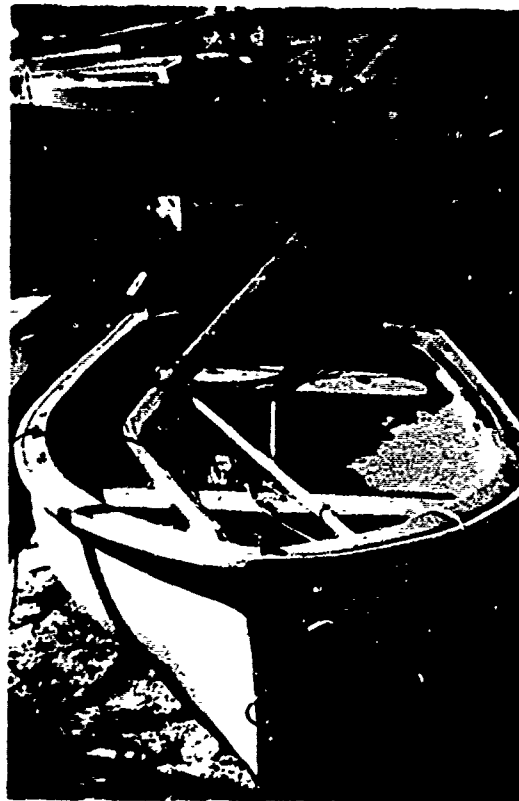
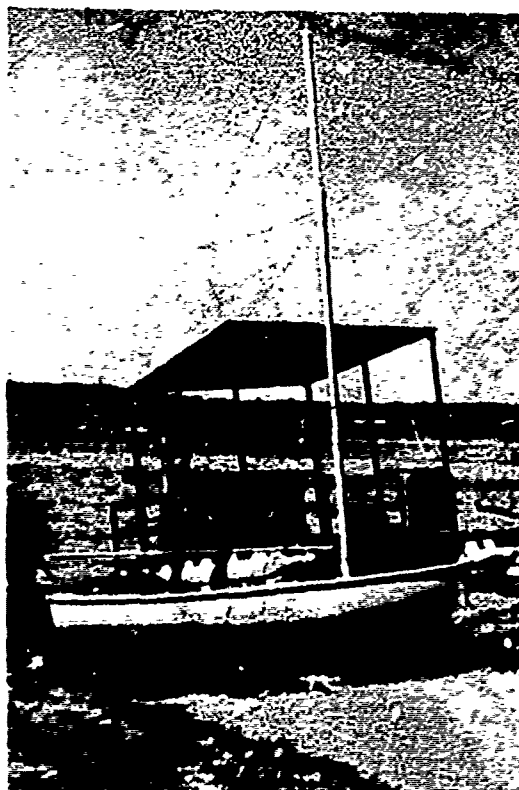
Figure 4. (Top) - Damaged Boat Showing Bent Mast  
(Bottom) - Sistership to Damaged Sailboat

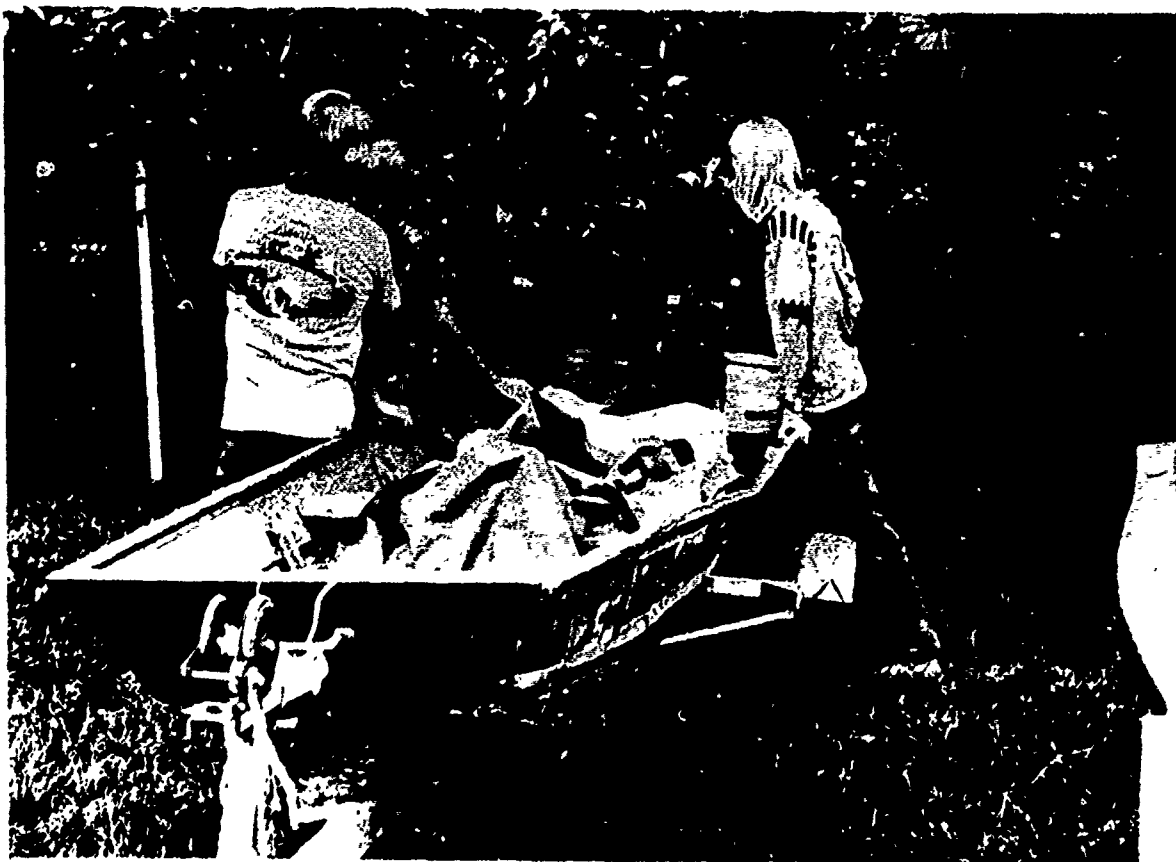
Figure 7      Johnboat - Note Patch Over Damaged Area
